morphological trend analysis of beach and shoreface along the Belgian coast

Job Janssens
Flanders hydraulics Research
Quest4D final workshop

morphological trend analysis: methodology

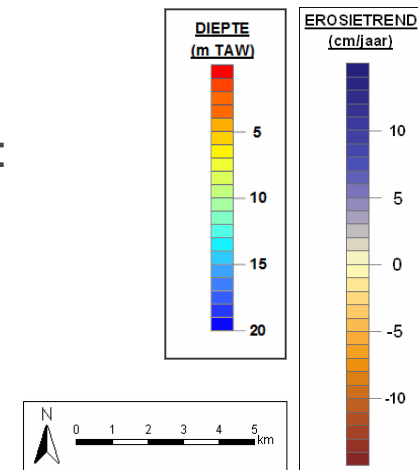
BATHYMETRIE

- weinig significante trends
- sedimentatietrend op kruin Nieuwpoortbank
- meest dynamische zone rond Potje / Trapegeer / Broersbank:
sedimentatie geul zuiden van Trapegeer
erosie Broersbank / verplaatsen Broersbank ?

NB: beperkte tijdreeks van dieptegegevens!
